Carter Off Road Park Inspection

Inspection Report: Carter Off Road Park, AFIN: 63-00000, Permit #: N/A

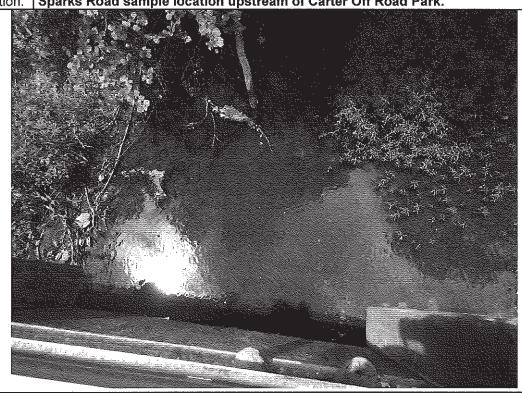
Water Division P	hotographic Ev	idence Sheet		
Location: C	arter Off Road Park		·		
Photographe	r: Jason Bolenbaugh	Date:	5/7/2015	Time:	~13:11
Witness: Cla	rk Baker and Chris Naus			Photo #	: 1
Decesiotions	Charles Dand comple leastion		ster Off Dead De	-1-

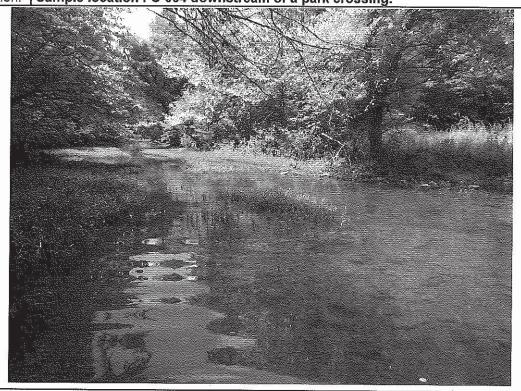
Witness: Jason Bolenbaugh and Chris Naus Photo #: 3

Description: Sample location FC-004 downstream of a park crossing.

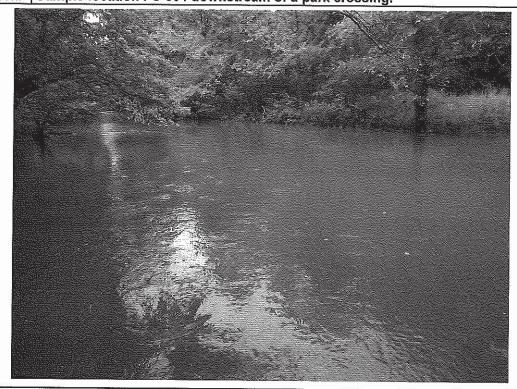
Photographer: Clark Baker Date: 5/9/2015 Time: ~13:10
Witness: Erica McAdoo, Chris Naus, and Jason Bolenbaugh Photo #: 4

Description: Sample location FC-004 downstream of a park crossing.

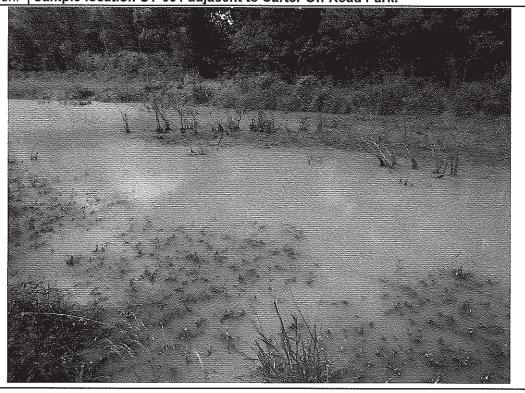
Photographer:Erica McAdooDate:5/9/2015Time:~14:40Witness:Jason BolenbaughPhoto #:10

On May 7, 2015, turbidity levels were 92.9 NTU on the unnamed tributary adjacent to Carter Off Road Park (UT-001), and on May 9, 2015, turbidity levels were 1770 NTU at the same location. These are in violation of ADPC&E Regulation 2.503.

Description: | Sample location UT-001 adjacent to Carter Off Road Park.

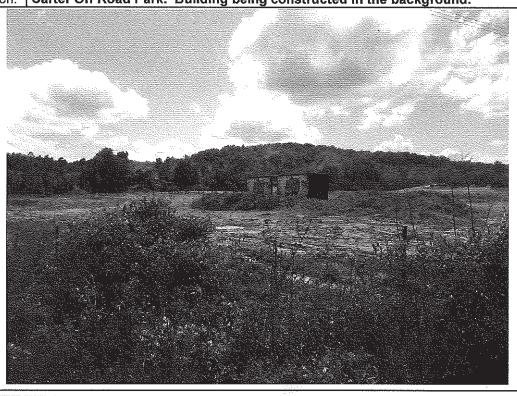
Carter Off Road Park, LLC is operating a large construction site without a Construction Storm Water permit for all construction and dirt work activities in violation of Arkansas Water and Pollution Control Act § 8-4-217(b)(1)(E).

Water Div	vision Photographic Evi	dence Sheet			
Location:	Car	ter Off Road Park					
Photograp	her:	Jason Bolenbaugh	Date:	5/7/2015	Time:	~1440	
Witness:	Witness: Clark Baker and Chris Naus Photo #: 13						
Description	n· C	arter Off Road Park	Building being constru	cted in the back	around	-

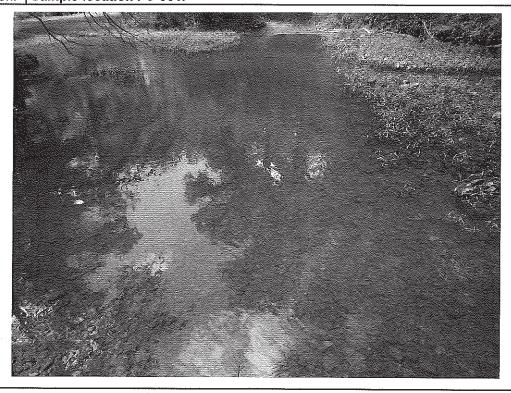
Water Division P	hotographic Evi	dence Sheet		
Location: Carter Off Road Park				
Photographer: Jason Bolenbaugh	Date:	5/7/2015	Time:	~14:59
Witness: Clark Baker and Chris Naus		-	Photo #	ž: 15
Description: Sample location FC-001.

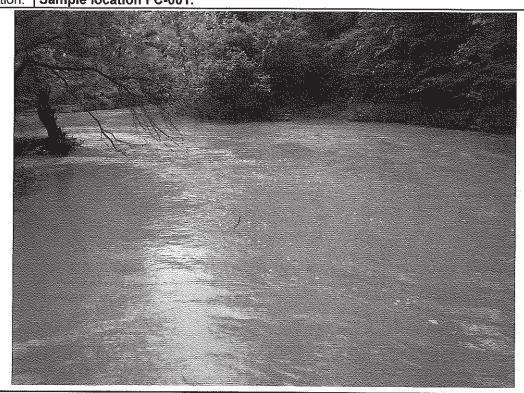
Photographer:Jason BolenbaughDate:5/9/2015Time:~14:57Witness:Erica McAdoo, Clark Baker, and Chris NausPhoto #:16Description:Sample location FC-001.

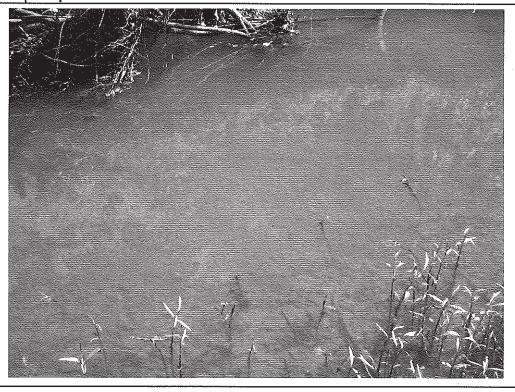
Water Division P	hotographic Evidence Sheet		
Location: Carter Off Road Park			
Photographer: Jason Bolenbaugh	Date: 5/7/2015	Time:	~15:07
Witness: Clark Baker and Chris Naus		Photo #	: 17
Description: Sample location FC-002.	, , , , , , , , , , , , , , , , , , , ,		-

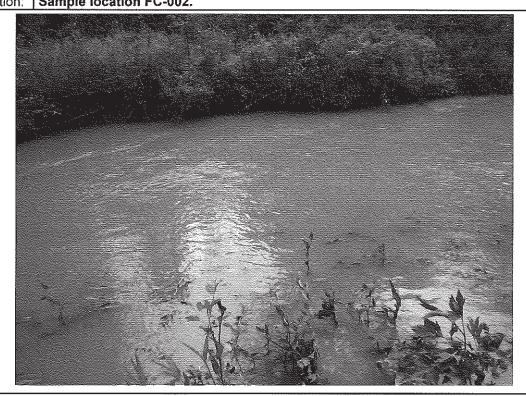
Photographer:Jason BolenbaughDate:5/9/2015Time:~15:25Witness:Erica McAdoo and Chris NausPhoto #:18Description:Sample location FC-002.

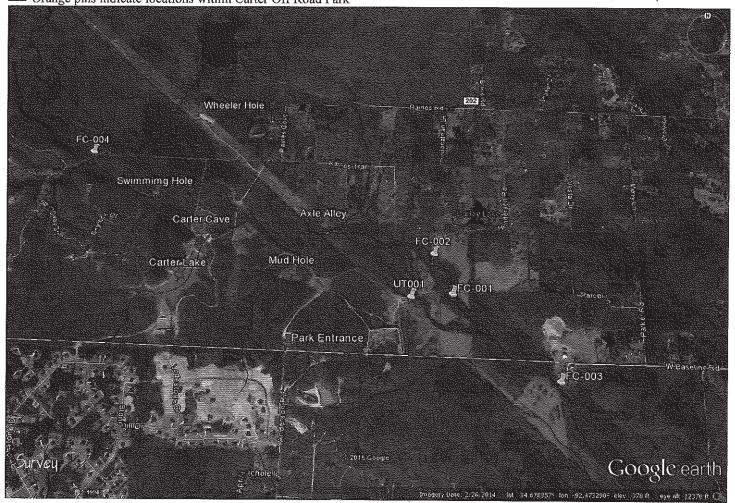
Figure 1. Google Earth Image of Area and Sample Points.

Yellow pins indicate sampling locations (Sparks Road sample location is not pictured but is northwest of FC-004)
Orange pins indicate locations within Carter Off Road Park

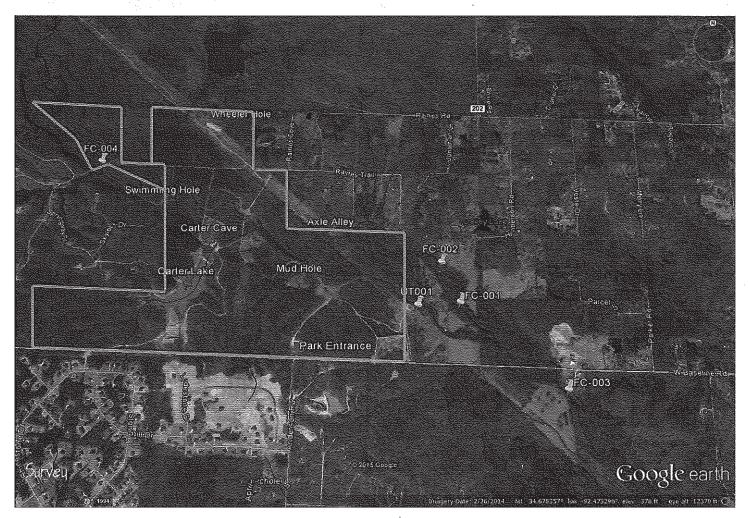
Figure 2. Google Earth Image of Saline County Assessor (Approximate) Property Boundaries for Carter Off Road Park, LLC.

- Yellow pins indicate sampling locations
- Orange pins indicate locations within Carter Off Road Park
- Approximate Property Boundary
